Due to simple human mistake at final automatic assembly line, it may happen that Your HYDRA audio-video scart switch, may not output proper sound range. Hydra consists of 8 scart INPUTS and 1 scart OUTPUT. At each INPUT sockets, there are two capacitors, filtering incoming audio:

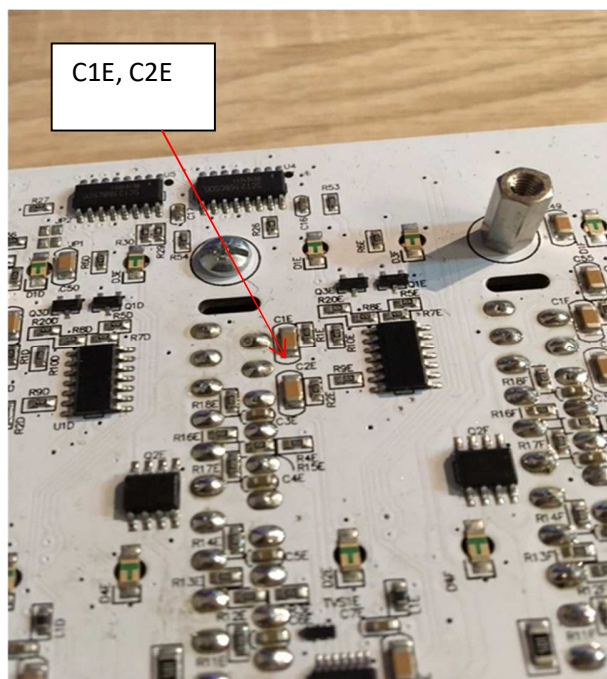
- Scart no 1: C1A,C2A
- Scart no 2: C1B, C2B
-
- Scart no 8: C1H, C2H

Problematic capacitors are largest ones – one below other. 2 pieces at each scart port. Height approx. 1mm.

Proper capacitors have approx. 5mm height. Cost for 100 pieces – 2Euros

1. Obtain **SMD 10uF 1206** size capacitors or contact me – I will send for free
2. Disconnect HYDRA power supply
3. Desolder 8 x 2 capacitors (16 pieces - two for each scart port) using proper tools.
4. Clean pads from solder
5. Solder proper capacitors

Please, test sound output at each scart socket.
